# Report on the Preliminary Air Leakage Testing of 8 Benson Place in Oxford, in compliance with ATTMA TSL1 (2010)

**Site address:** 8 Benson Place, Oxford, OX2 6QH

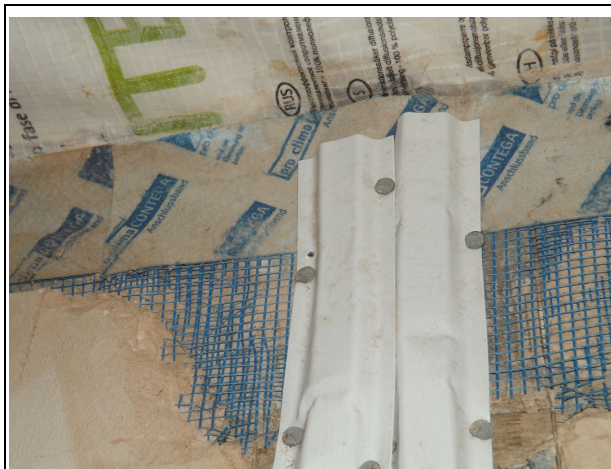
P11) Leakage behind conduit, removed and wall parged before final test

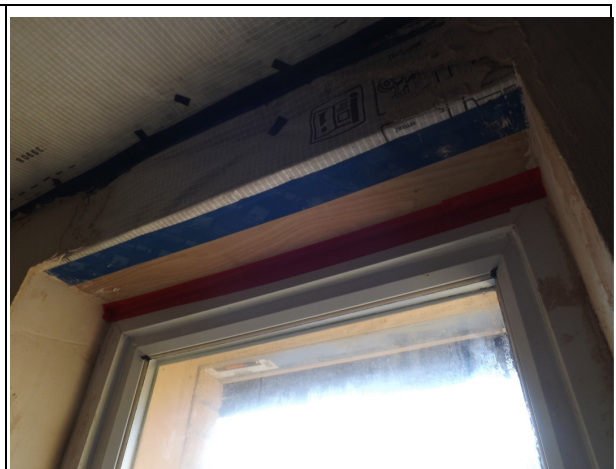
P12) Red tape sealing crack across top of existing window

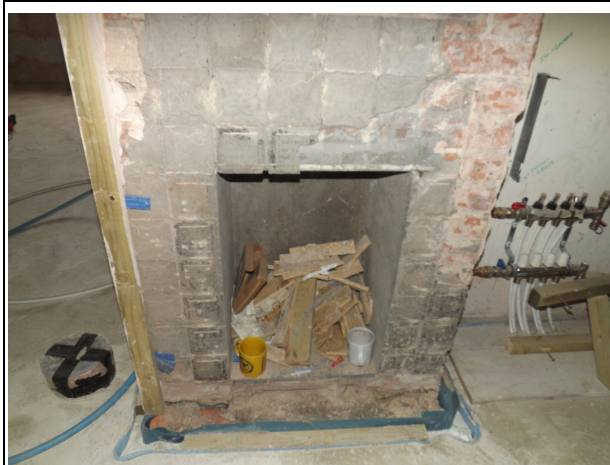
P13) Leakage in various gaps in brickwork at locations around existing fireplace

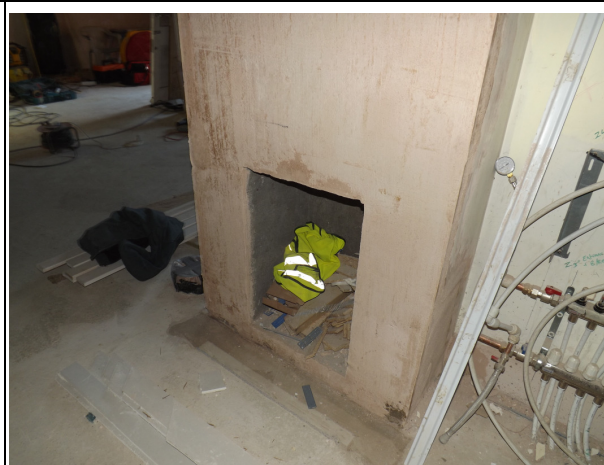
P14) Fireplace completely parged before final test

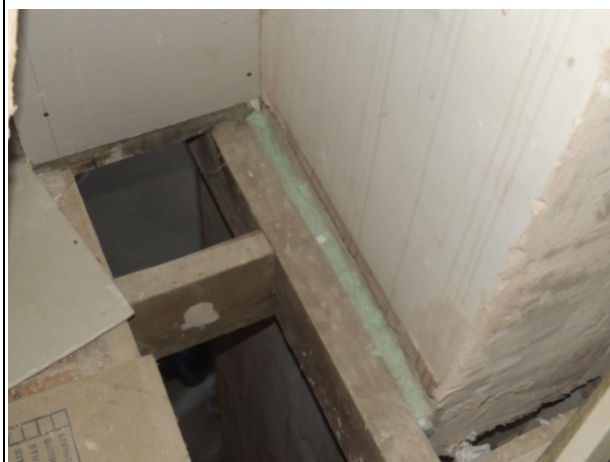
P15) Expanding foam used to seal void behind intermediate floor joist near existing chimney

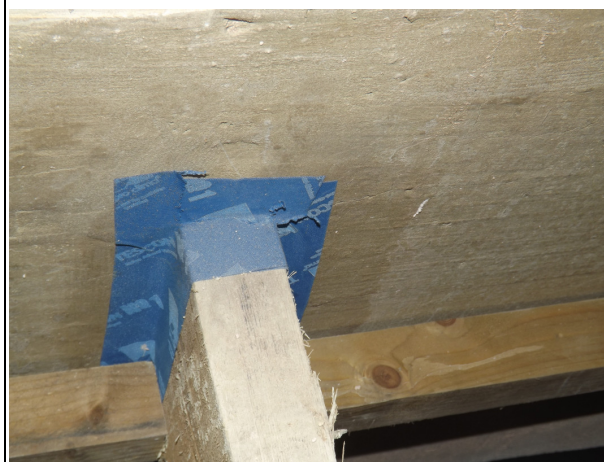
P16) Tape seal around end of floor joist into wall

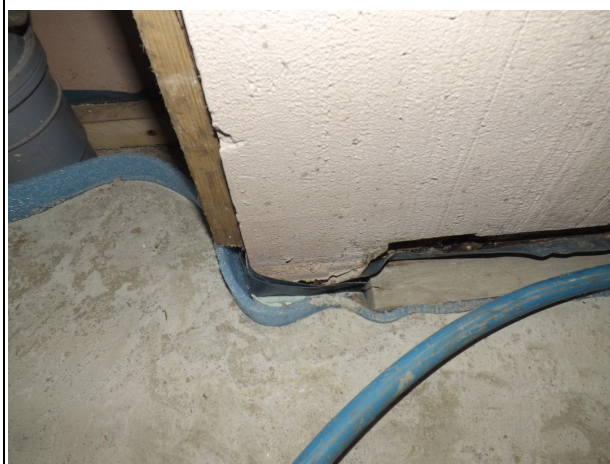
P17) Leakage found at edge of floor behind existing chimney
